Restabilize Settling Historical Home – Palm Beach

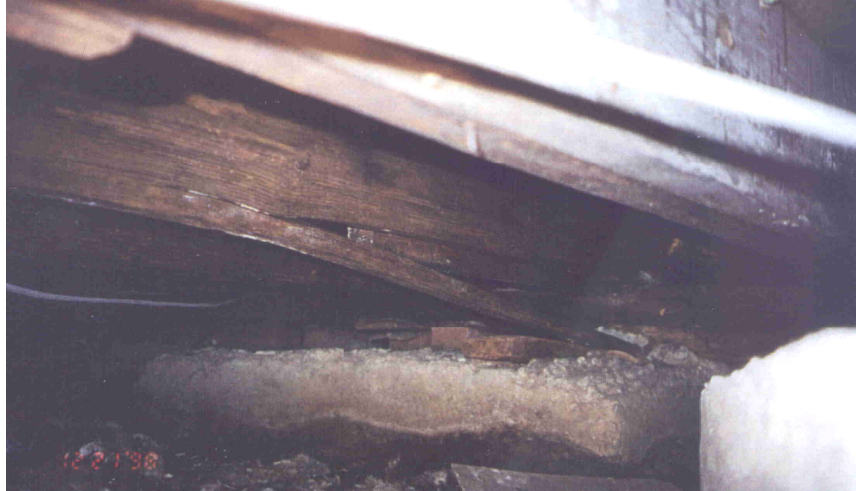
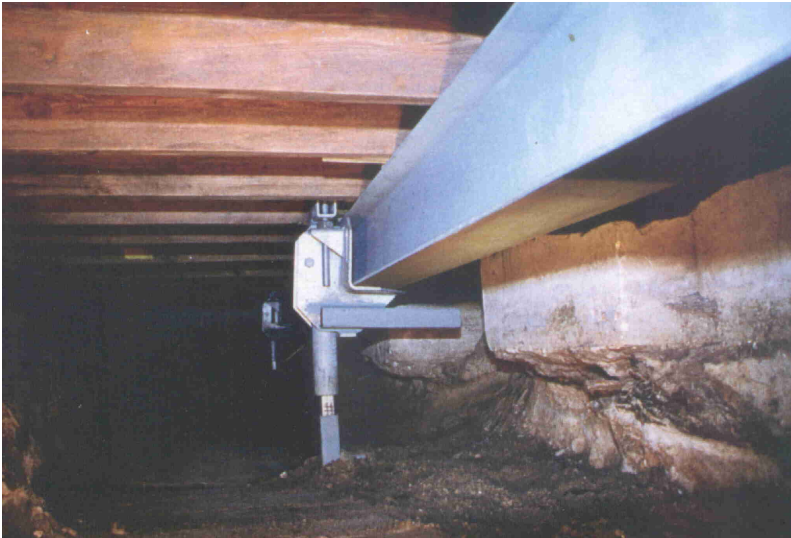
The owners of a Palm Beach Island residence built in the 1920's experienced uneven floors, sticking windows and doors, and cracks in the exterior of their home. These problems were caused by foundation settling and wood rot. Because the owners wanted to maintain the original hardwood floor in the home, access was not available through the floor for the installation of a helical pile anchor system. All work was confined to the crawlspace under the home.

New wood joists were installed. A series of helical piles were installed, then custom designed brackets were attached to accept new steel "I" beams. After being fastened to the brackets, the beams were then raised and leveled to straighten the floor joists.
